POL PIER REPAIRS  
LAJES FIELD, AZORES

CONSTRUCTION INSPECTION VISIT NO. 2  
JULY 1980

CONTRACT NO. N-62477-79-C-0021  
MODIFICATION P-00001

**OLKO ENGINEERING**  
CONSULTANTS • DESIGNERS

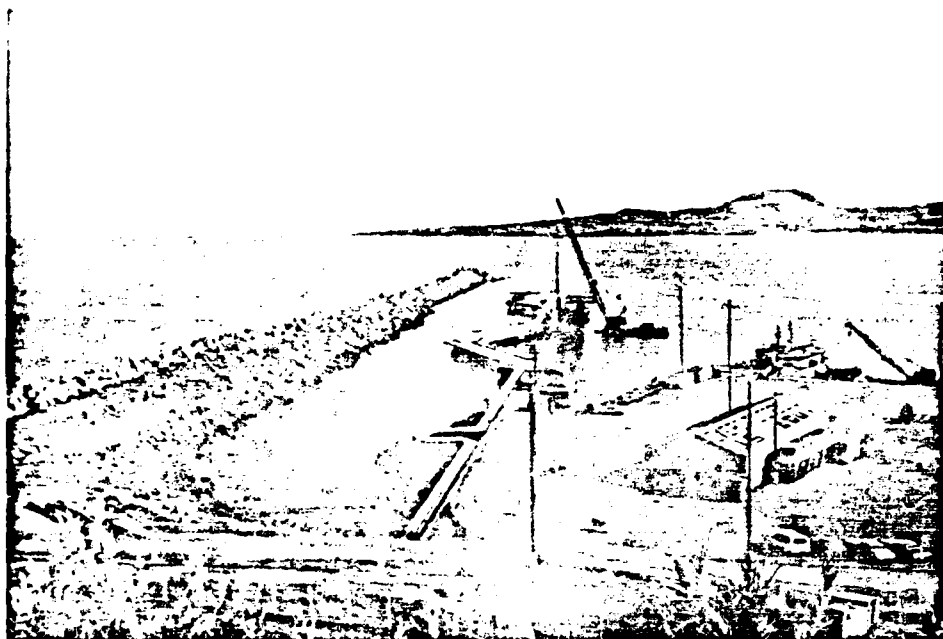
POL PIER - OVERALL VIEW  
Barge Crane at New North Dolphin

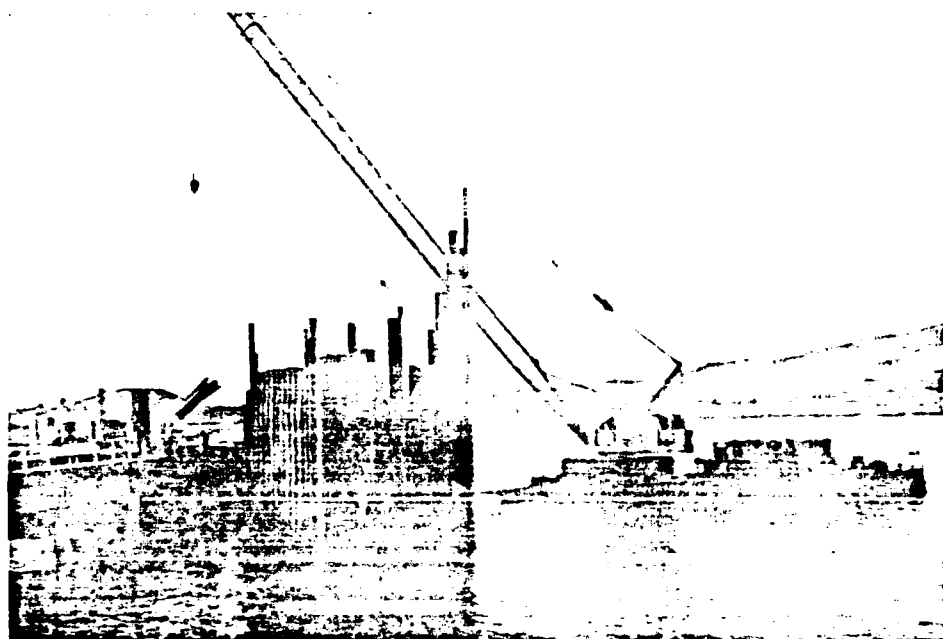
NEW NORTH DOLPHIN  
Threading the West Wall and Driving at the Other  
Three Walls to Level the Sheet Piles

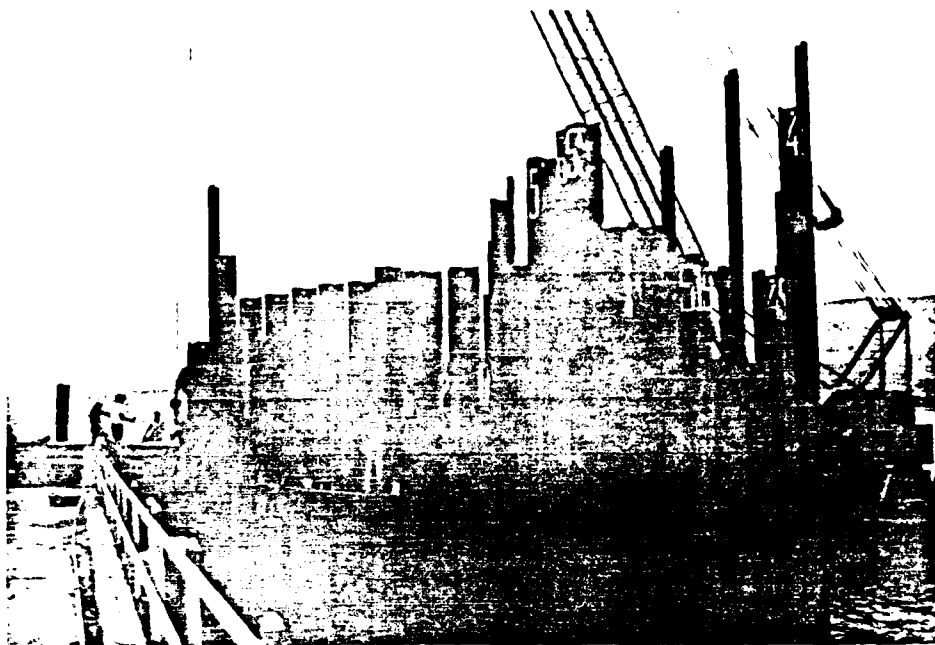
NEW NORTH DOLPHIN  
Epoxy Paint Touch Up of Abraded Sheet Piles.

It was noted that due to handling, some of the piles were badly scraped and epoxy paint retouching was needed. Accordingly, the Contractor started this operation as the sheets were being driven. He had an epoxy paint, supposedly suitable for both above and underwater use, for touch up of the steel sheet piling. It is manufactured by American Metaseal Company, 509 Washington Avenue, Carlstadt, New Jersey 07072, telephone: (201) 933-1720.

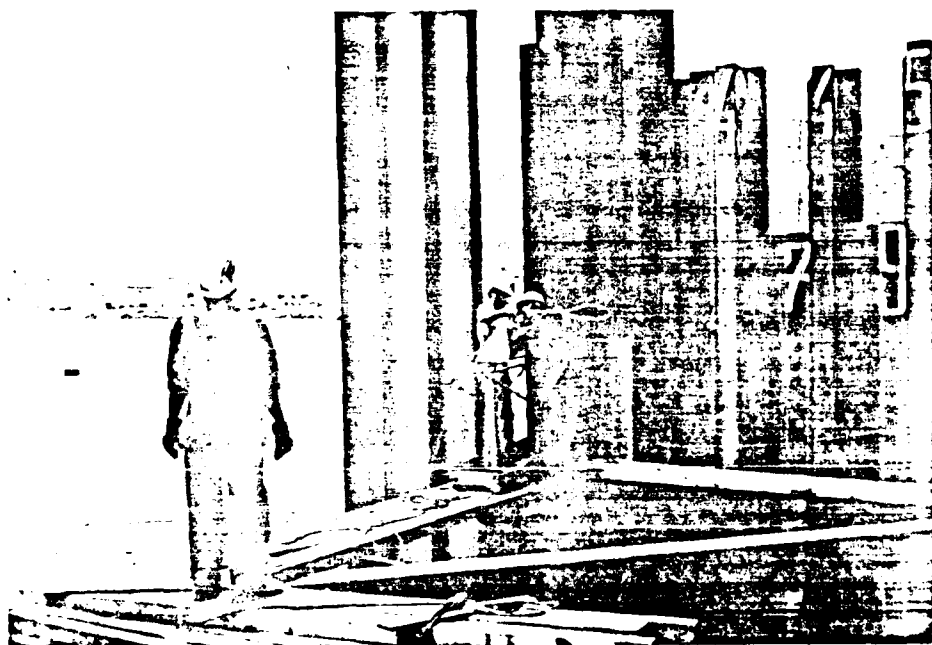
NEW NORTH DOLPHIN  
Threading Sheets at the North End of the West Wall.  
The Other Three Walls Have Been Partially Driven.

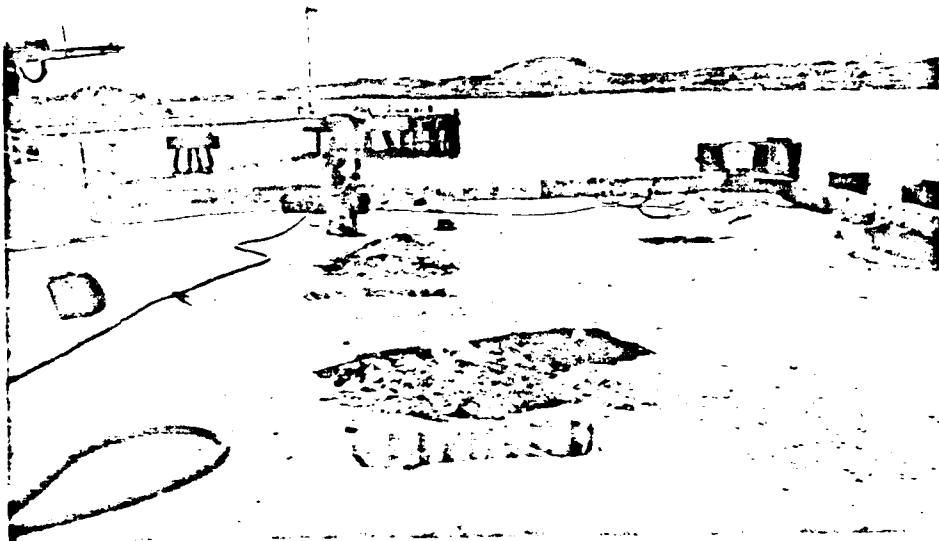
#### LOADING PLATFORM

Openings in Deck for Batter Pile Tie Downs, at South End of Loading Platform.

During this second site visit of July 1980, the Contractor had already chipped out the decking at the four southernmost batter piles of Bents 13 to 16, inclusive. Each opening in the deck surface was about 18 inches wide in a north-south direction, and about 40 inches long in an east-west direction, parallel to the pile cap. The reinforcing steel was exposed in each of the deck openings and the depth to which the concrete had been jackhammered out varied from about 8 inches to 16 inches down. The reinforcing steel was about 7 inches from the top of the slab. It was noted that in many areas the top reinforcement was spliced at this particular area of the pile cap.

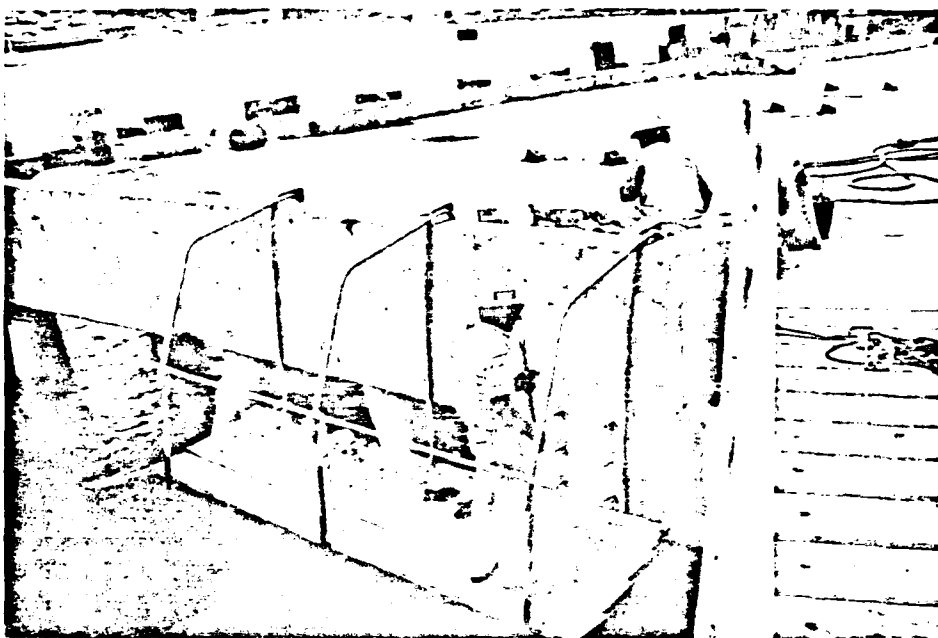
LOADING PLATFORM - SOUTH END  
Installing Bolts to Tie-In the Template for the New  
South Dolphin.
